V. OPTION 2: NEW MASONRY VENEER OVER CONCRETE WALLS

1.3. Overall Description of the Option 2 Reconstruction Approach

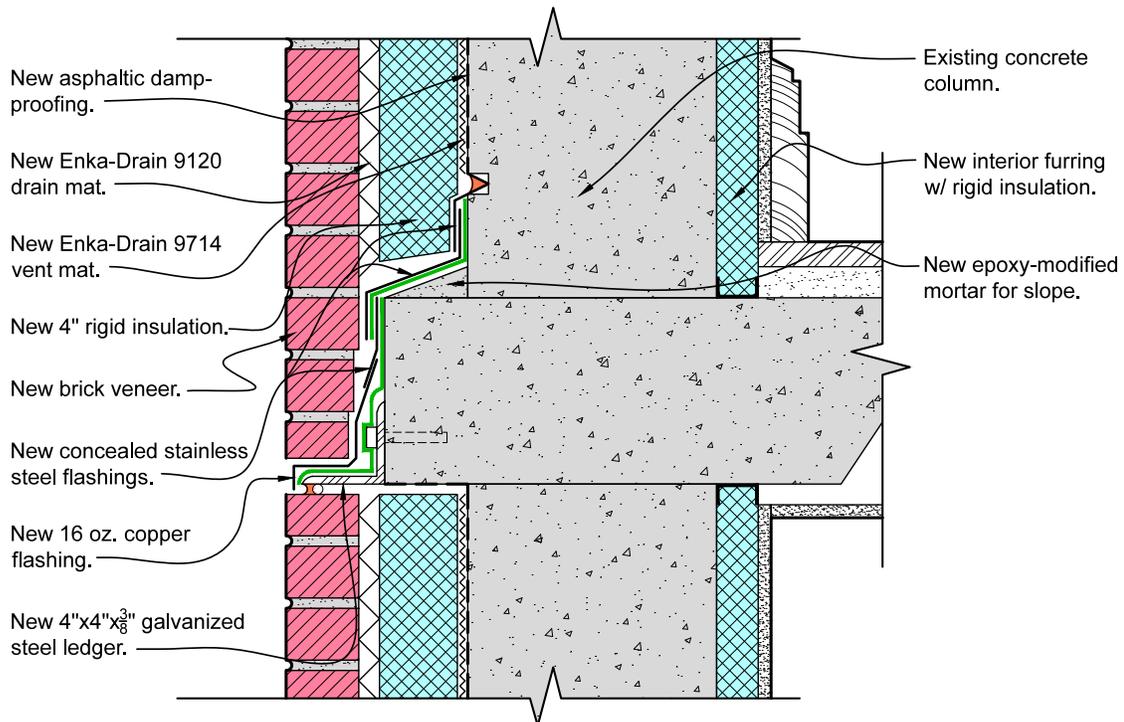
Figure V-1.3(1): Typical New Brick Veneer Over Existing Concrete Column

Figure V-1.3(1) shows a typical exterior detail where it occurs over the existing embedded concrete columns.

The ledgers and the existing protruding concrete lugs are flashed with a double-layer flashing assembly of self-adhered flashing membrane capped with 26-gage stainless steel flashings where fully concealed, and with 16 oz. copper flashings where these become exposed to view.

New stainless steel veneer anchor channels, such as Dur-O-Wal DA904, are fastened to the concrete walls, spaced 16" apart horizontally, and vertically continuous.

A thin vent mat, such as Enka-Drain 9714, is placed against the damp-proofed concrete walls, with 4" thick extruded polystyrene insulation, such as Dow Board, placed against this. Stainless steel veneer anchors, such as Dur-O-Wal DA931, are clipped into the channel slots, spaced 18" apart vertically. A thicker drain mat, such as Enka-Drain 9120, is placed over the insulation, fabric-side facing outward, to limit mortar clogging.

A new masonry veneer, consisting of ASTM C-216 face brick, Grade SW, at brick areas, or pre-cast concrete cladding at stone locations, is installed over this, largely to match the existing appearance, but with greatly reduced offsets and with concave-tooled mortar joints to limit water infiltration into the masonry. Horizontal 9-gage stainless steel wire seismic joint reinforcing is embedded within the horizontal joints spaced 18" apart vertically.

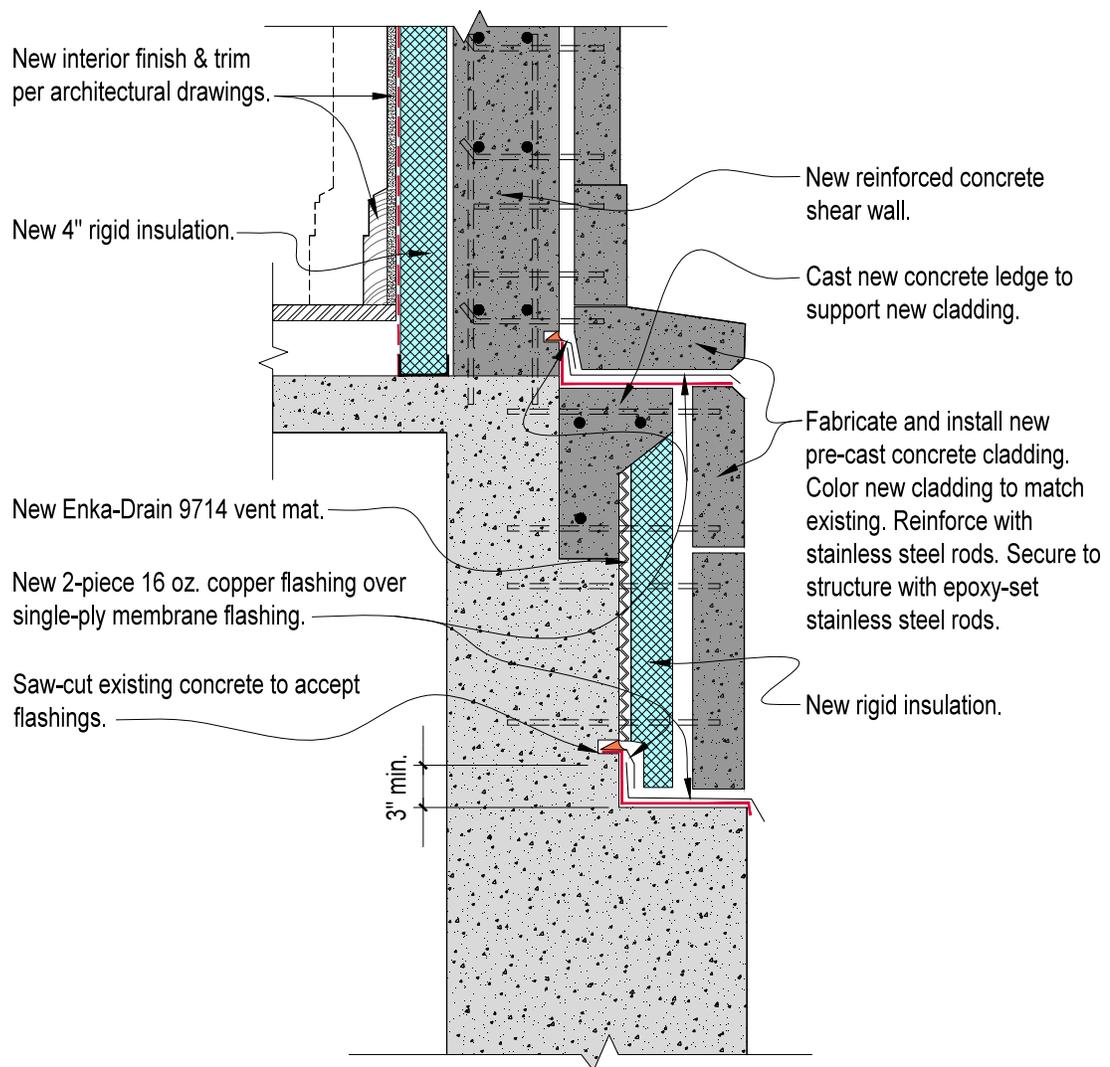
Fig. V-3.4(1): Stone Base Replacement with Replacement of Cladding Above

In brief, the work consists of replacement of this band with a pre-cast concrete cladding per subsection IV-3.4.2. As subsection IV-3.4.2 described the stabilization of the stone cladding above this, rather than its removal, Figure V-3.4(1) depicts the Option 2 work.

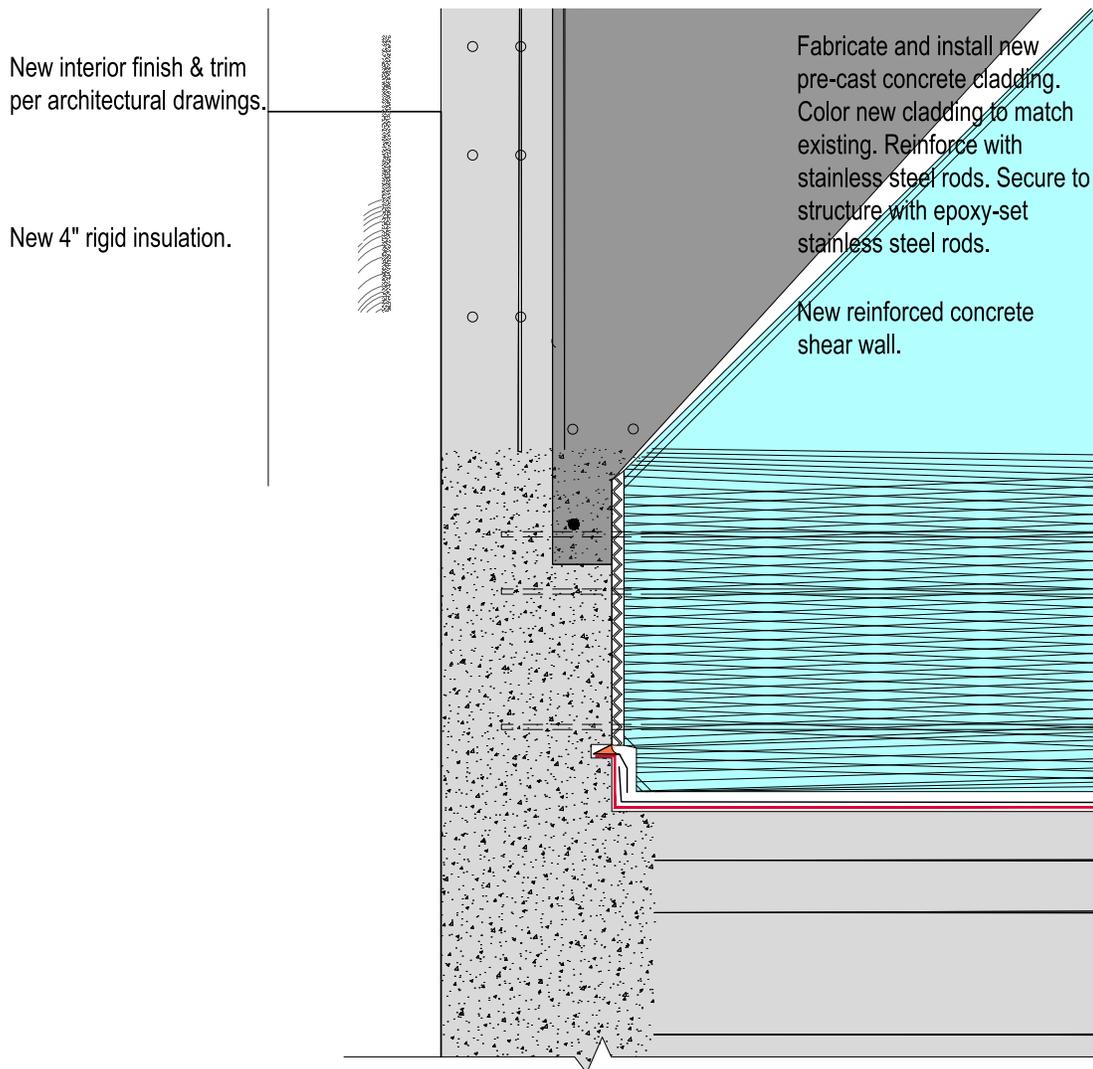
Fig. V-3.5(1): Stone Cladding Replacement

In general terms, the Cladding Replacement approach is depicted in Figure IV-3.5(1), and the verbal description of the work follows the drawing.

The new cladding should be integrally colored and textured to match the existing stone cladding's appearance, and it should be reinforced only with stainless steel reinforcing to avoid future corrosion spalling. For cost estimating purposes, the cladding should be assumed 4" thick.

It can be anchored to the structure with epoxy-set stainless steel threaded rods, or with stainless steel embedded clips, etc.

Regardless of specific anchoring method, all anchors should be type 304 stainless steel to avoid corrosion. The number of anchors per cladding piece will vary, depending on size of cladding piece being secured, but no fewer than two anchors should secure each piece, and at least one anchor should occur for every 2 SF.

However, most of the cladding occurs over existing concrete columns, which would be drilled from the exterior. The existing concrete walls should be drilled at least 4" deep, and roughly 1/2" \emptyset stainless steel threaded rods should be epoxy-set into these holes. The rods should be of sufficient length to penetrate into the cladding to within 1 1/2" of its outer surface.

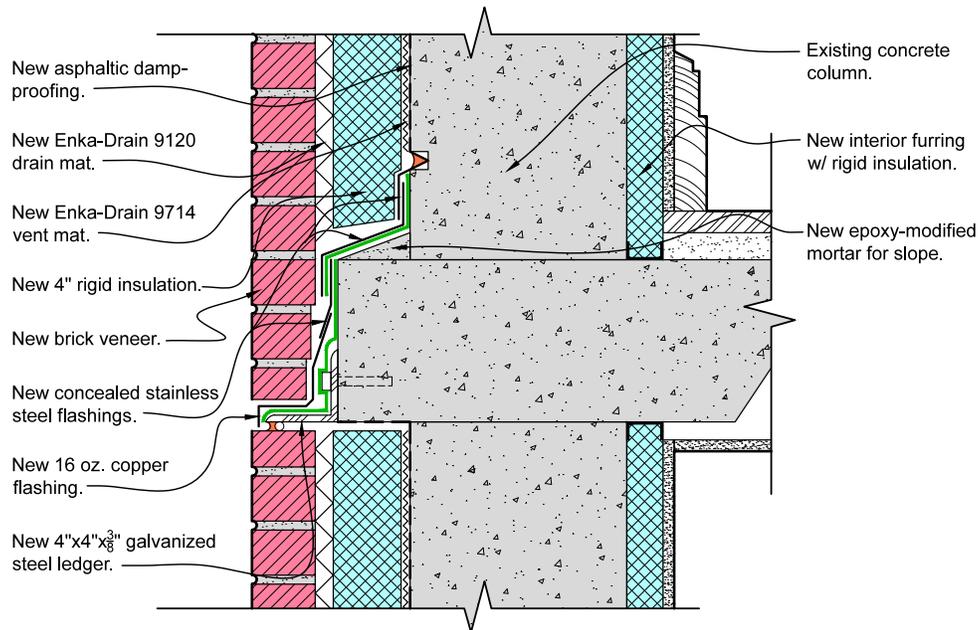
Figure V-3.6(1): Typical New Brick Veneer Over Existing Concrete Column

Figure V-3.6(1) shows a typical exterior detail where it occurs over the existing embedded concrete columns. Figure V-3.6(2) shows a comparable detail at the windows. Figures V-3.6(3 & 4) show a very similar in-progress stone veneer assembly.

The ledgers and the existing protruding concrete lugs are flashed with a double-layer flashing assembly of self-adhered flashing membrane capped with 26-gage stainless steel flashings where fully concealed, and with 16 oz. copper flashings where these become exposed to view.

New stainless steel veneer anchor channels, such as Dur-O-Wal DA904, are fastened to the concrete walls, spaced 16" apart horizontally, and vertically continuous.

A thin vent mat, such as Enka-Drain 9714, is placed against the damp-proofed concrete walls, and 4" thick extruded polystyrene insulation, such as Dow Board, is placed against this. Stainless steel veneer anchors, such as Dur-O-Wal DA931, are clipped into the channel slots, spaced 18" apart vertically. A thicker drain mat, such as Enka-Drain 9120, is placed over the insulation, fabric-side facing outward, to limit mortar clogging.

A new brick veneer is installed over this, largely to match the existing appearance, but with greatly reduced offsets and with concave-tooled mortar joints to limit water infiltration into the masonry. Horizontal 9-gage stainless steel wire seismic joint reinforcing is embedded within the horizontal joints spaced 18" apart vertically.

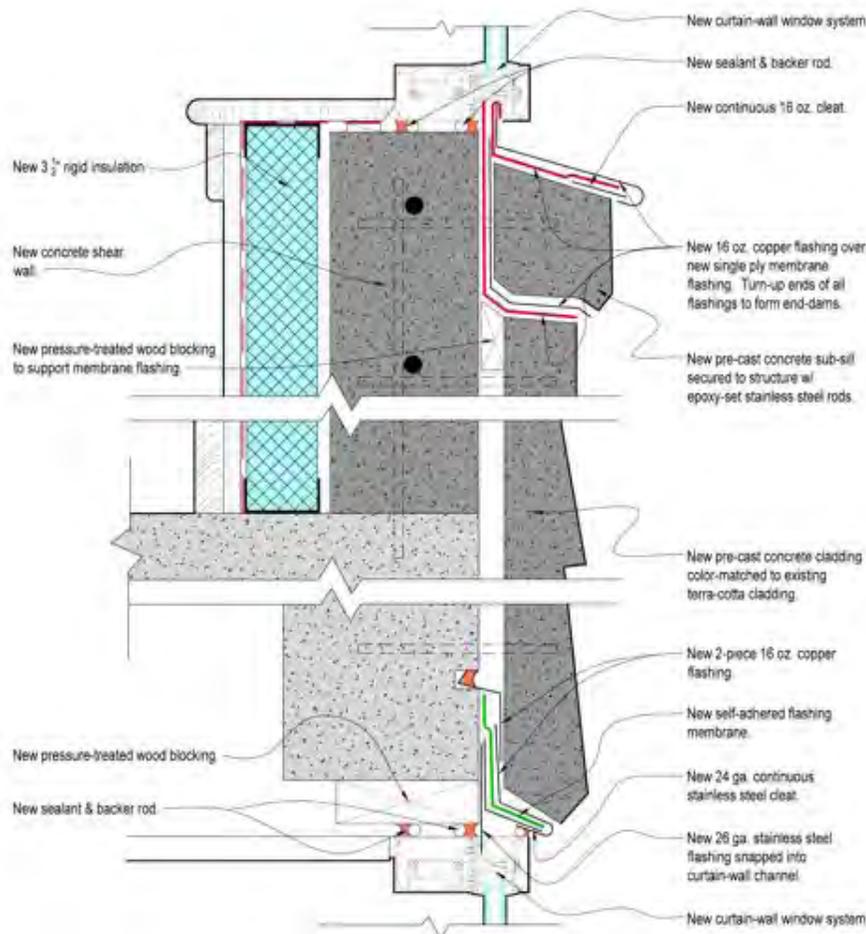
Fig. V-3.7(1): Replacement of Terra-Cotta Panels With Pre-Cast Concrete Panels

To slow degradation, I recommend that these replacement panels consist of two pieces, one consisting of a sill piece directly below the windows, and the other below this, with a double-layer flashing of adhered single-ply membrane capped with 16 oz. copper installed between these two as well as atop the sill. The upper sill flashing should integrate with the new curtain-wall windows recommended in subsection V-3.12.2. The single-ply membrane flashing should wrap over the top of the copper flashing to avoid contact between the aluminum window frame and the copper flashing. Figure V-3.7(1) shows a generic detail for this work.

The work includes wholesale replacement of these panels, either with pre-cast concrete, or Glass-Fiber-Reinforced-Concrete, (GFRC). Terra-cotta would obviously be closest in appearance, but would likely be more costly. Also, as these panels are one color, pre-cast concrete or GFRC can be integrally colored to match the existing terra-cotta. The panels can be secured with embedded stainless steel clips, epoxy-set threaded rods, or similar methods.

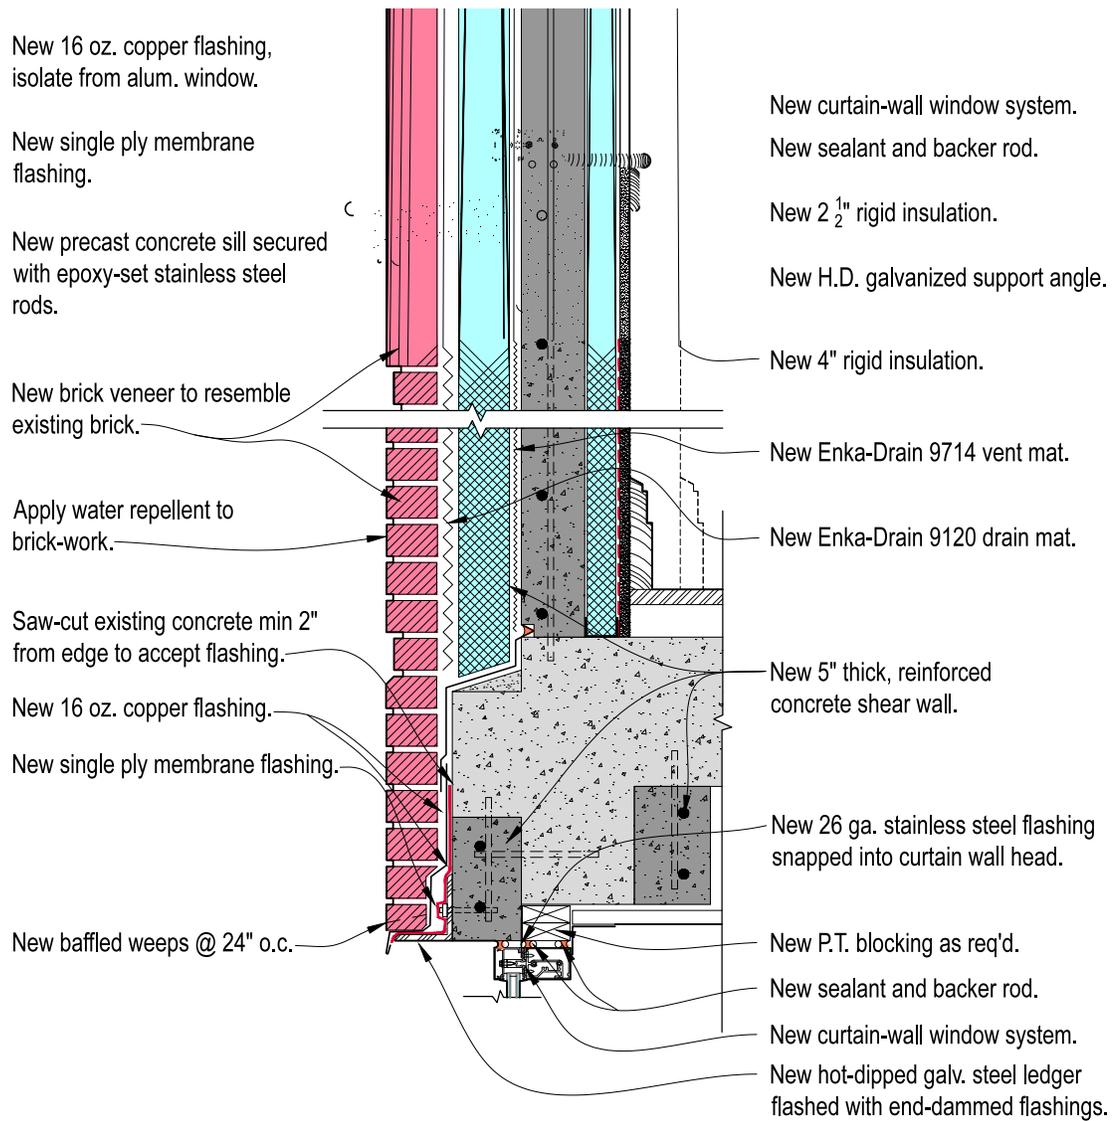
Figure V-3.8(1): Typical New Brick Veneer at Windows

Figure V-3.8(1) shows a similar exterior detail where it occurs at the windows. This detail pertains specifically to the more public walls addressed in subsection V-3.6.2, and does not represent the condition at the courtyard walls with complete accuracy. However, it should be close enough for cost-estimating purposes.

The ledgers are flashed with a double-layer flashing assembly of self-adhered flashing membrane capped with 26-gage stainless steel flashings where fully concealed, and with 16 oz. copper flashings where these become exposed to view.

New stainless steel veneer anchor channels, such as Dur-O-Wal DA904, are fastened to the concrete walls, spaced 16" apart horizontally, and vertically continuous.

A thin vent mat, such as Enka-Drain 9714, is placed against the damp-proofed concrete walls, and 4" thick extruded polystyrene insulation, such as Dow Board, is placed against this. Stainless steel veneer anchors, such as Dur-O-Wal DA931, are clipped into the channel slots, spaced 18" apart vertically. A thicker drain mat, such as Enka-Drain 9120, is placed over the insulation, fabric-side facing outward, to limit mortar clogging.

A new masonry veneer, consisting of ASTM C-216 face brick, Grade SW, is installed over this, largely to match the existing appearance. Horizontal 9-gage stainless steel wire seismic joint reinforcing is embedded within the horizontal joints spaced 18" apart vertically.

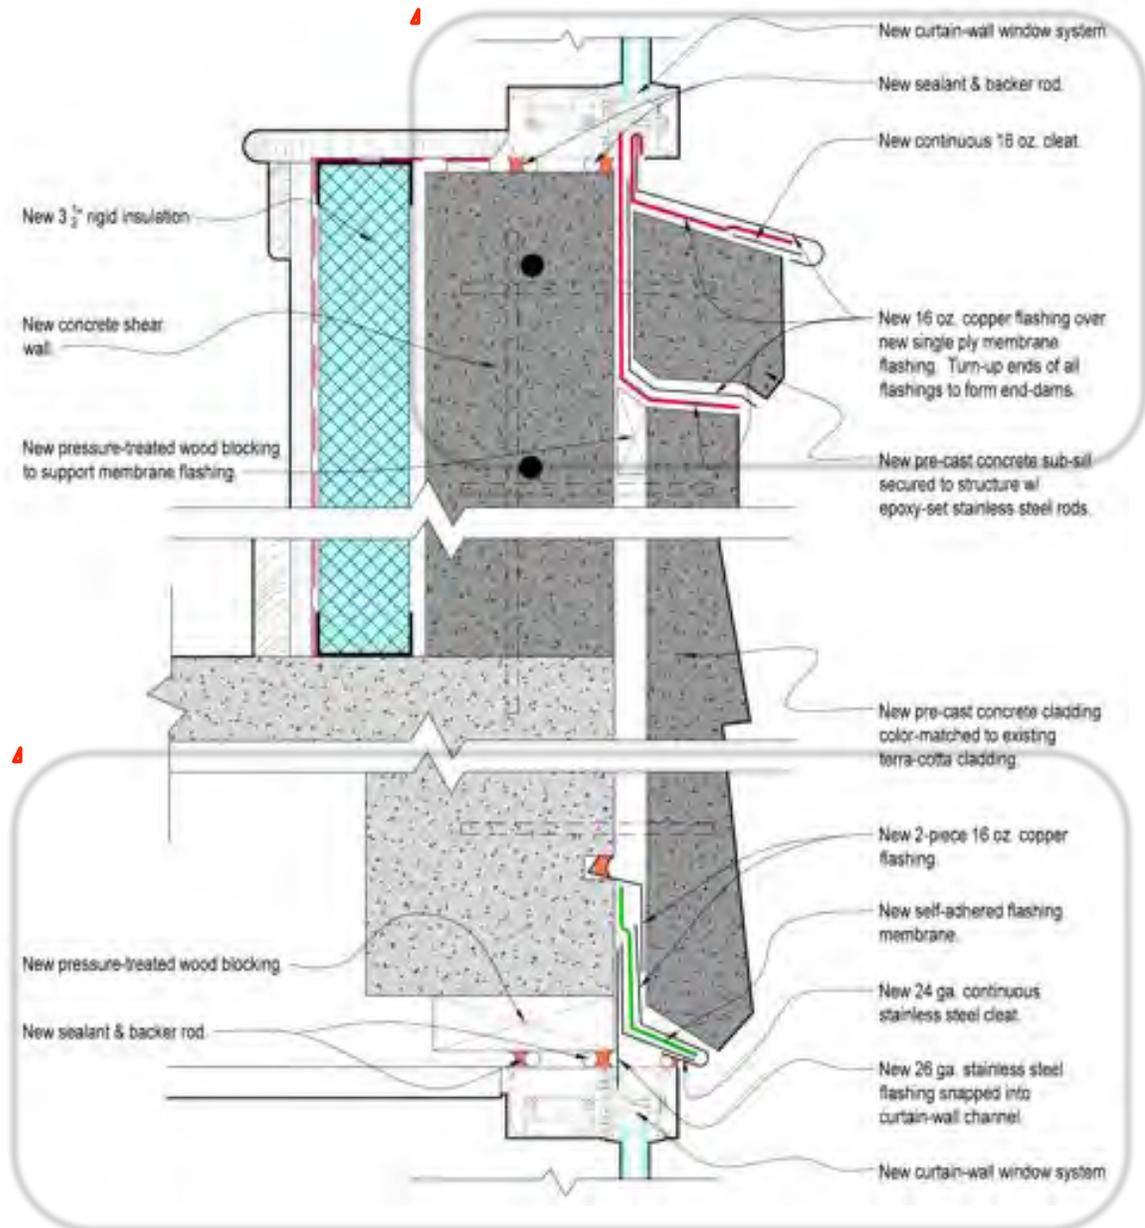
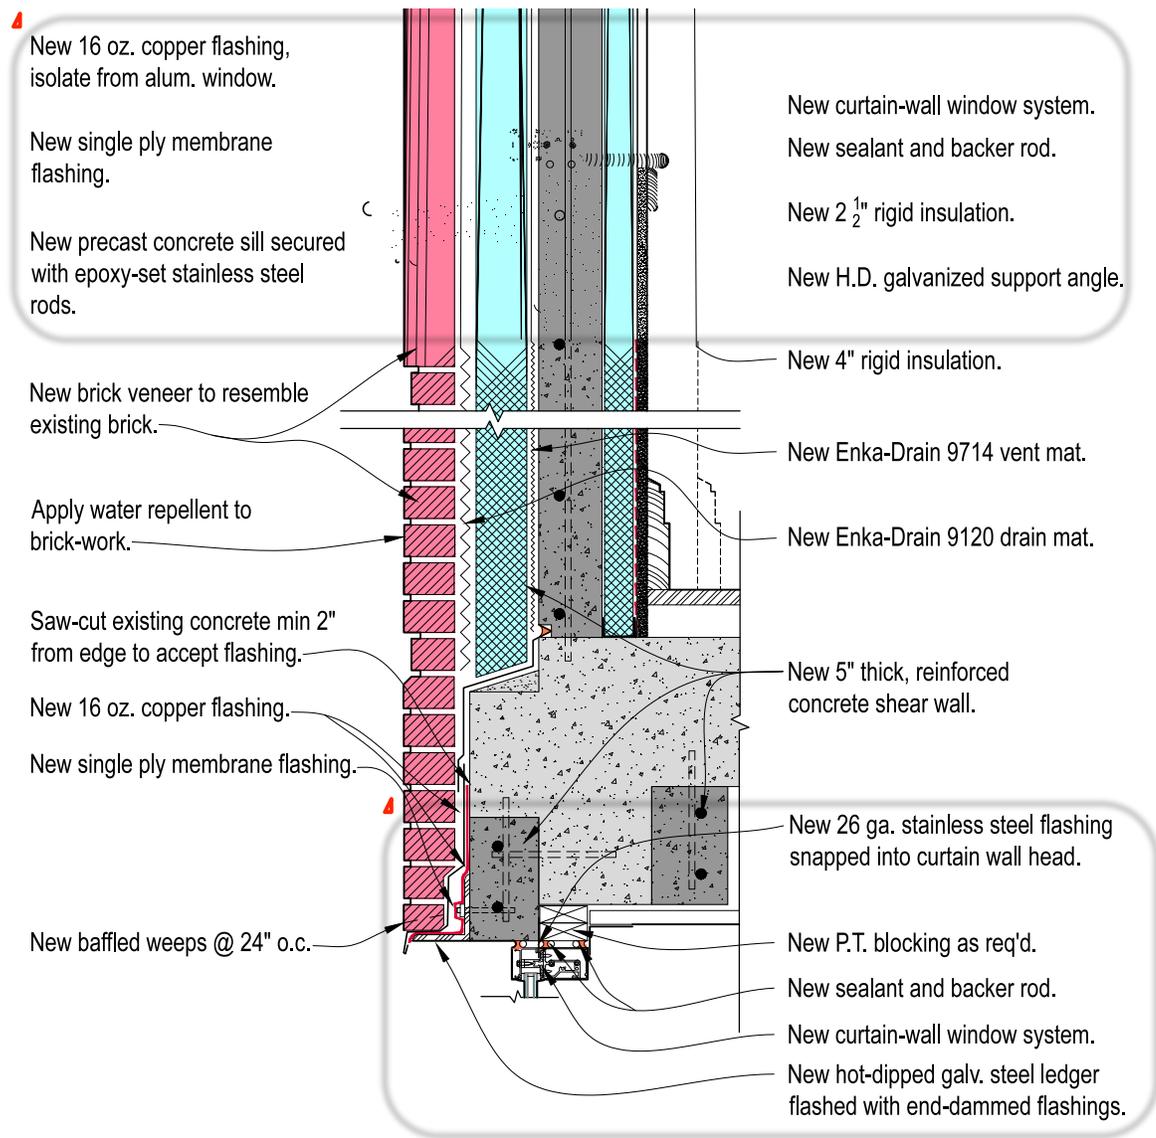
Figures V-3.12(1 & 2) depict typical window installation details for most conditions on this building.

In brief, the work consists of complete replacement of all windows with a new curtain-wall system with operable sashes integrated as needed to match the current window configurations.

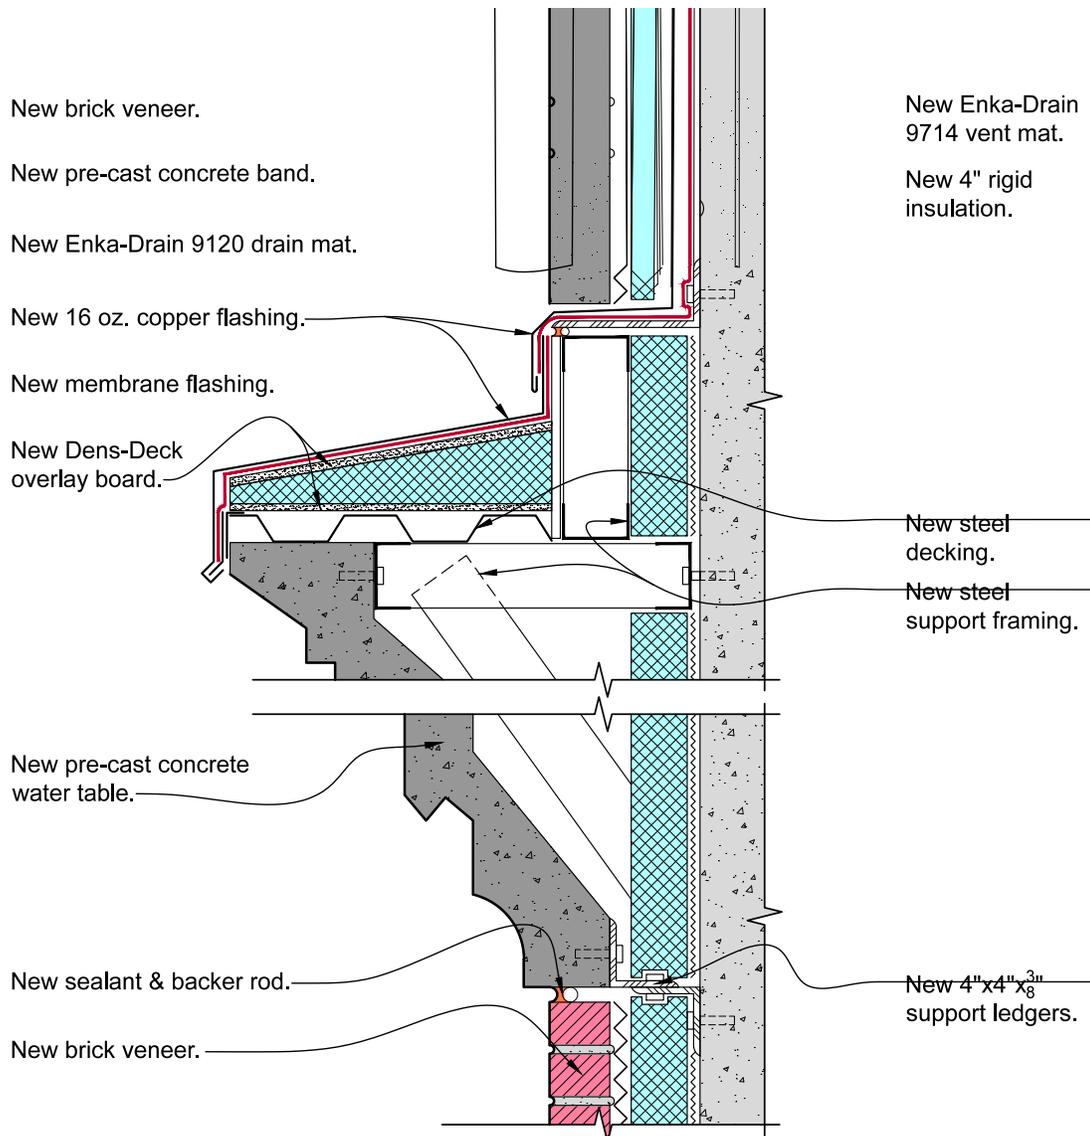
Fig. V-4.1(1): Water Table Reconstruction

Replacement of this water table with a pre-cast concrete one is recommended. Figure V-4.1(1) depicts the general scope of this work.

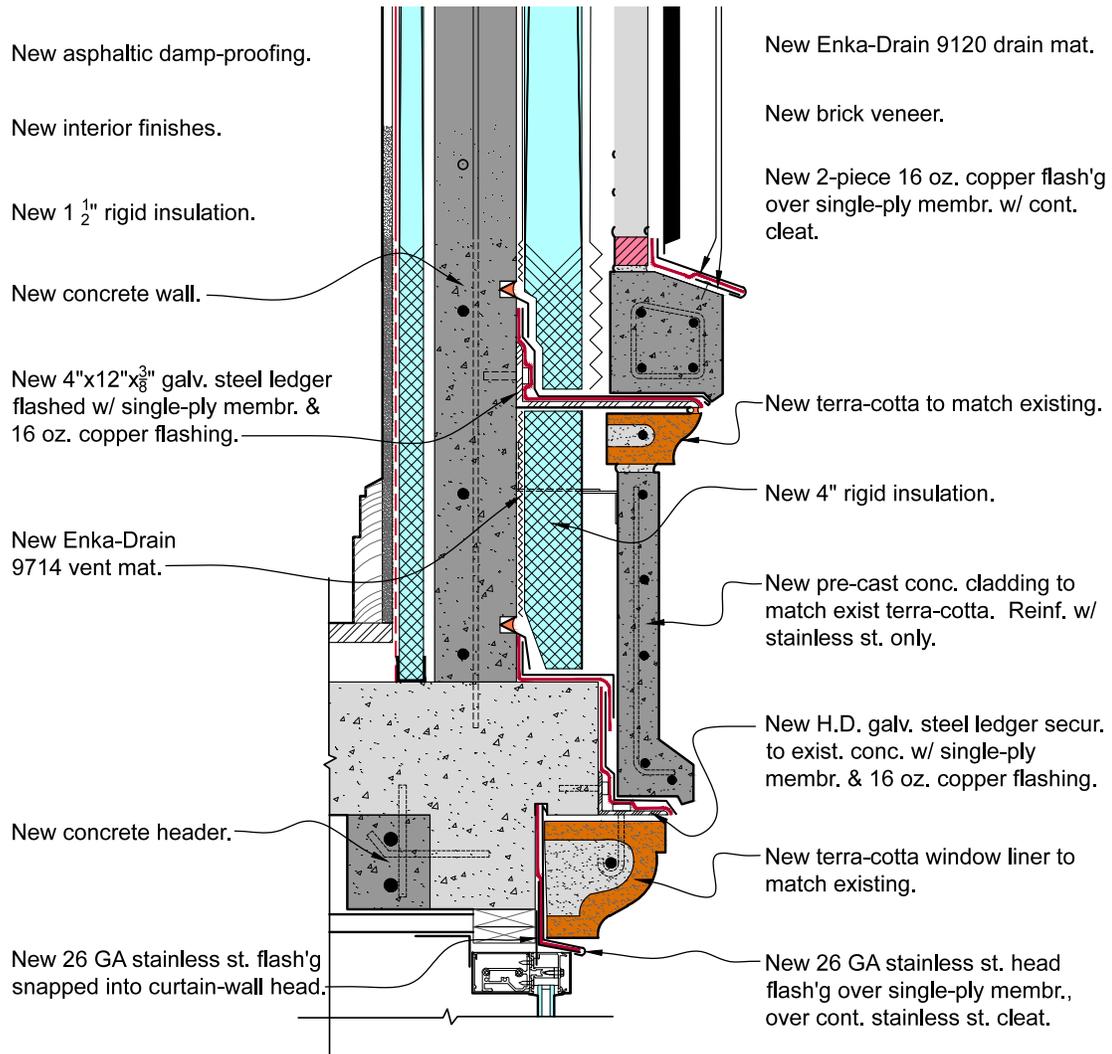
Fig. V-4.3(1): Terra-Cotta Water Table Band Replacement Abv. Level 4 Windows

In brief, the work consists of replacing the entire band with new pre-cast concrete and terra-cotta pieces, along with installation of new, continuous steel support ledgers above the level 4 windows and above the adjacent brick, and below the new pre-cast concrete water table, as well as installation of new flashing caps and through-wall flashings. Figure V-4.3(1) depicts this work.

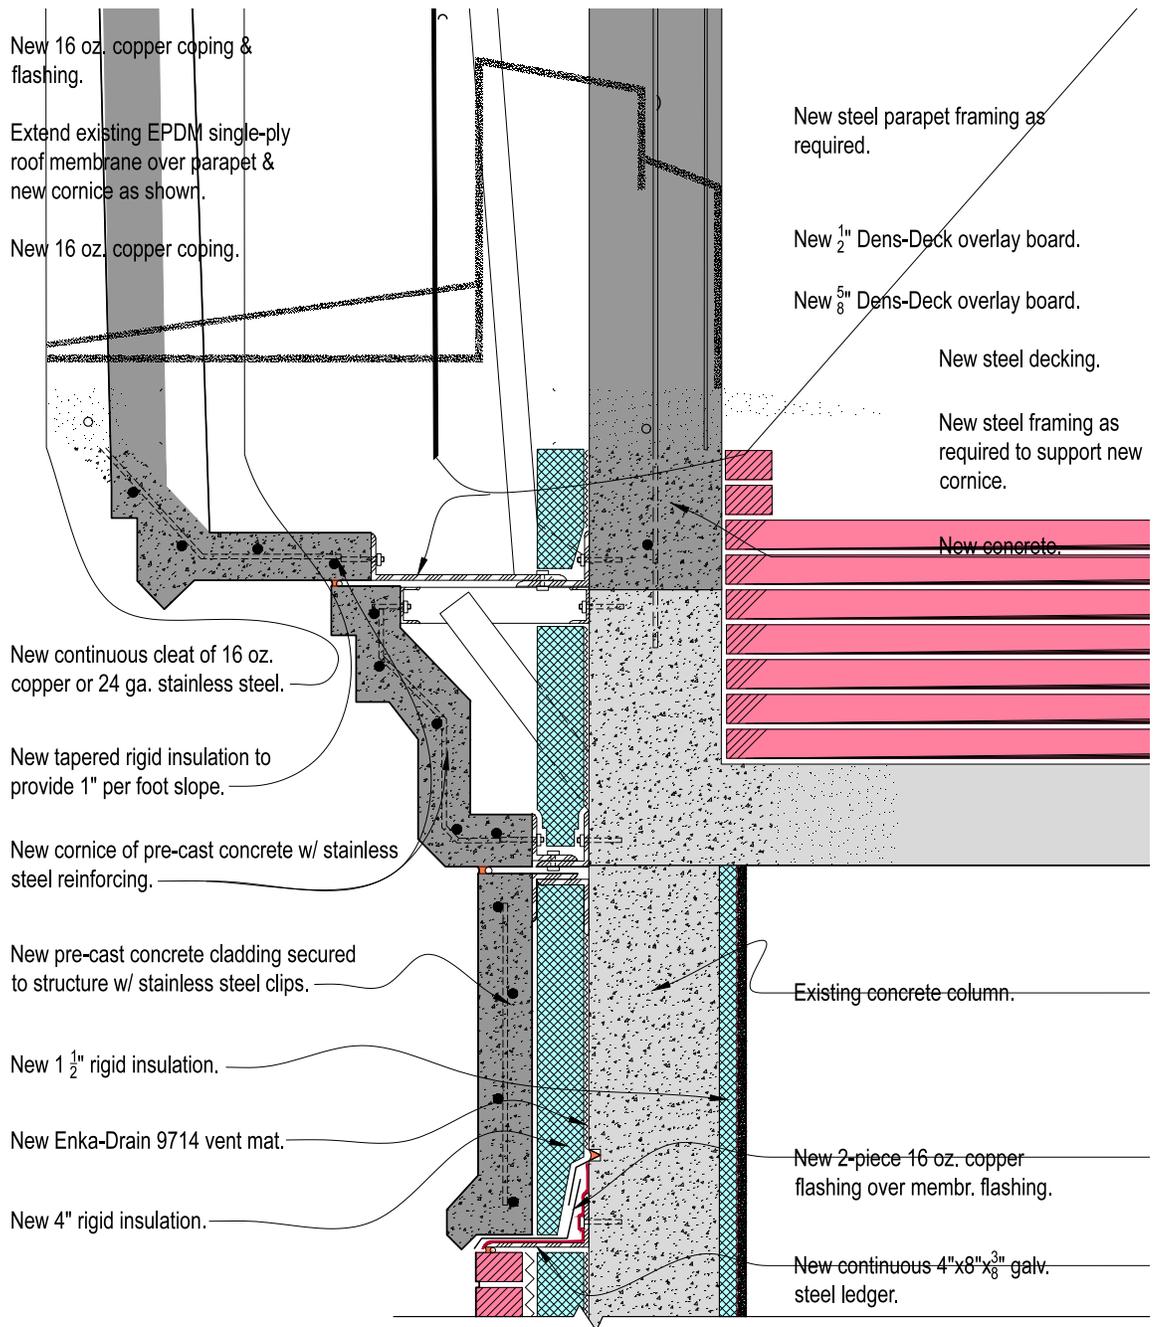
Fig. V-4.5(1): General Configuration of New Cornice

Figure V-4.5(1) illustrates the general construction of the recommended cornice.

Above this, a new structural support framework of hot-dipped galvanized steel would be constructed, capped with galvanized steel decking. Pre-cast concrete soffit panels, fabricated to mimic the original cornice and reinforced with stainless steel, would then be secured to this steel support structure.

Finally, a 16 oz. copper cap flashing would be secured over this, and would be counter-flashed along the parapet face with another 16 oz. copper flashing. This counter-flashing could be fabricated to interlock with a new 16 oz. copper parapet coping, though this could also be secured with a separate cleat.

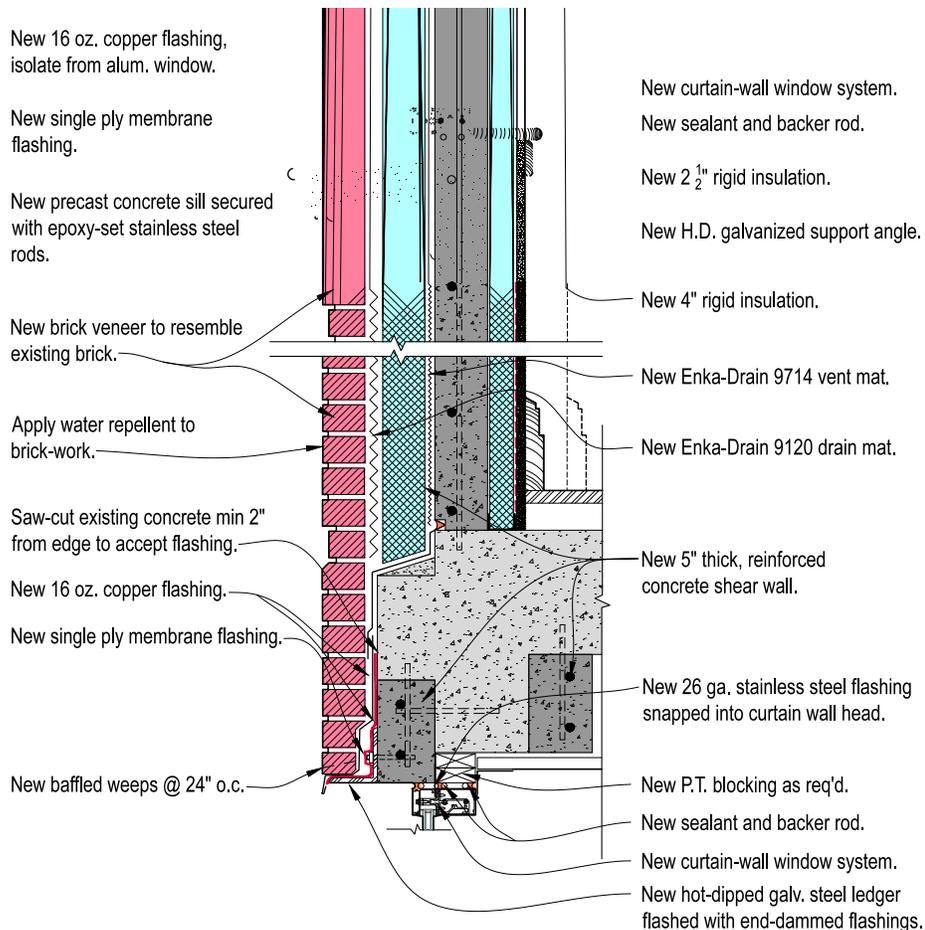
Fig. V-4.7(1): Window-Head Lintel Replacement and Flashing

Although many of the existing lintels are still in decent condition and could provide several decades of additional life, their current un-flashed configuration contributes to scattered interior leakage, and the scope of this retrofit project warrants replacement of the outer, accessible lintels as part of this approach. This work is depicted in Figure IV-4.7(1).

In brief, this work consists of replacing these lintels with new, hot-dipped galvanized steel ledgers. These should be flashed with 2-layer flashings consisting of membrane flashings, such as Cetco Core-Flash 60, capped with 3-piece copper flashings, as shown in Figure V-4.7(1). Baffled weeps spaced 24" apart should be included for drainage.
